Project Background

In 2003, Mackworth personnel designed, fabricated, and installed a particulate control system barrier in the Back River in an effort to reduce phosphorus inputs from the tributary.

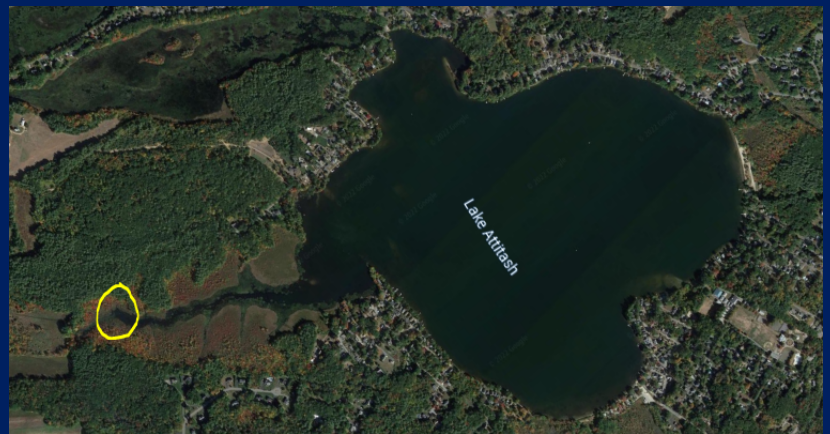
Figure 1. Aerial view of barrier placement (circled in yellow) for Lake Attitash project

It was positioned well up in the Back River and spans the full length across from bank to bank. The curtain was anchored to the contour of the waterbed floor. Its ends were secured on the shore and mushroom anchors were deployed upstream and downstream to help hold its configuration across a wide range of flow conditions. The system also had a 10-foot section specially designed for passage of kayaks, canoes, or small watercraft. The system was designed to allow river flow over the top of the flotation during high flow events.

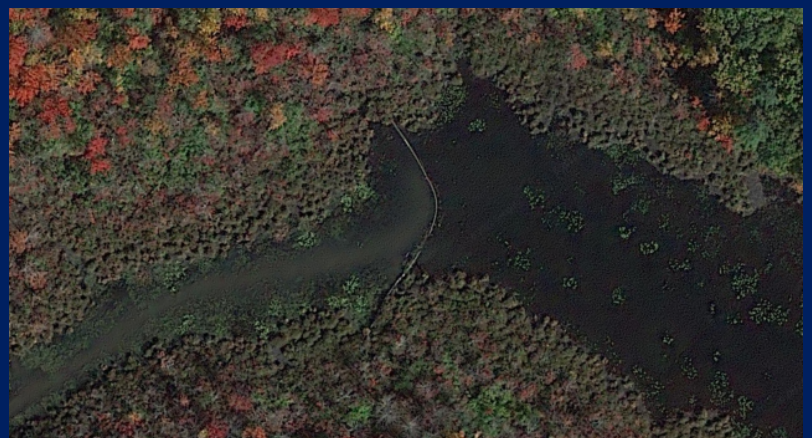
Figure 2. Aerial view of upstream barrier vs downstream barrier

The most recent google earth images available for the barrier location further support evidence of noticeable phosphorus removal below the barrier. Overall, while phosphorus data on lake Attitash is variable with large gaps in years and sites, available data indicate a minimum average reduction of 43% for total phosphorus downstream of the barrier per season.

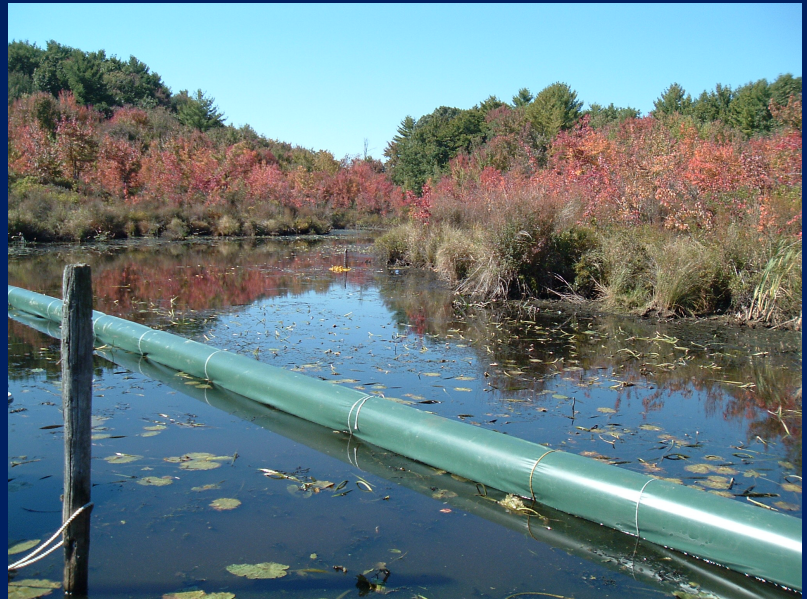
Figure 3. Boom installed across the Back River

The final design was a floating boom; approximately 140 feet long with a filter curtain that averages 6 feet deep along its perimeter. The system was constructed in one piece consisting of flotation hood assembly, double sided filtration curtain, ballast chain pocket w/chain and mooring attachment points.
