Project Background

Mackworth-Enviro partnered with a lake association in Sanford, Maine to address nutrient runoff from a local golf course higher up in the watershed.

The project was a pilot application for Mackworth’s nutrient barrier technology, with a target of 40% reduction in total phosphorus from the inlet stream. The Mackworth team designed, fabricated, and installed a three-barrier system, or NRB (nutrient reduction barrier), within Country Club Brook.

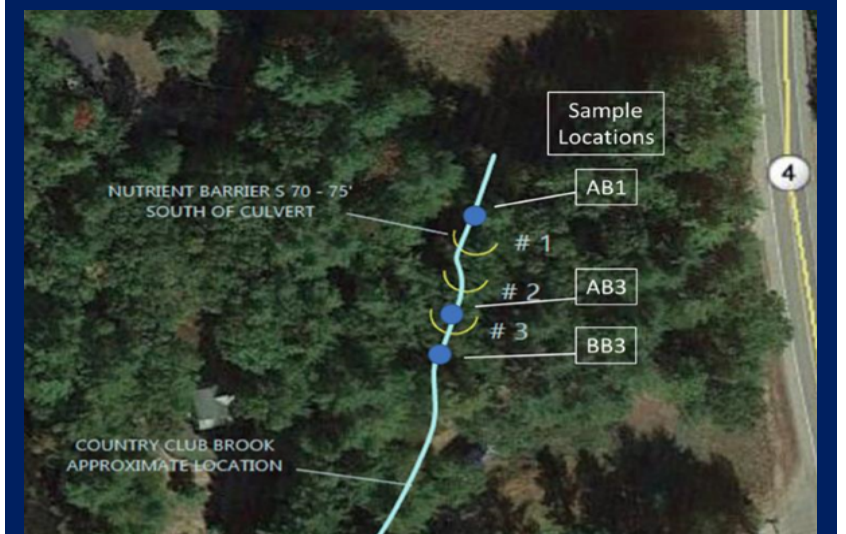
Figure 4. Map of County Club Brook with sampling locations

The data was collected during three sampling seasons (May- September) from 2018 to 2020.

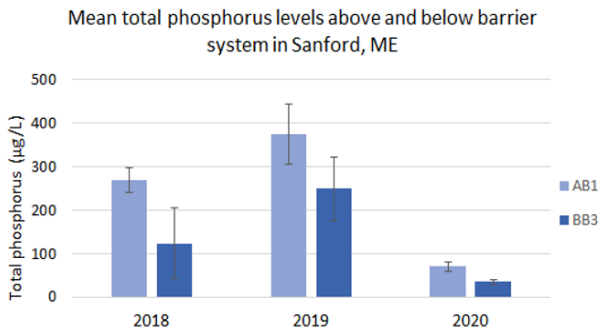
Figure 1. Mean total phosphorus levels above (AB1) and below (BB3) barrier system from 2018-2020

Over the course of three years, the Bauneg Beg Lake system averaged a 55% total phosphorus removal and a 60% ortho-phosphate removal from the inlet stream per season.

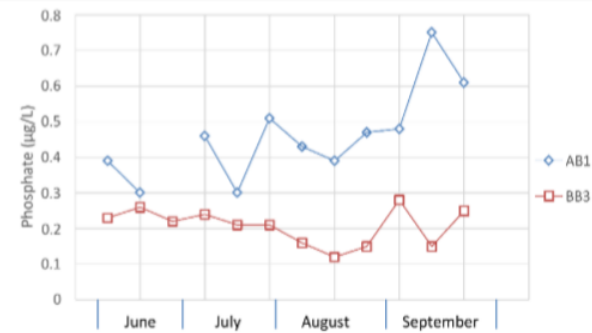
Figure 2. Ortho-phosphate levels above (AB1) and below (BB3) barrier system over time in the 2019 season

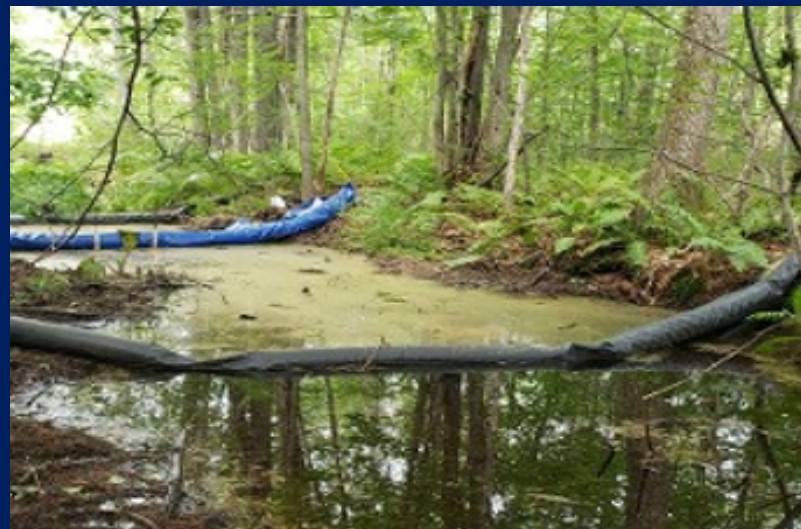
Figure 6. Downstream view of deployed system
