Project Background

Mackworth-Enviro designed, installed, and maintained operations on two bottom-sealing filter barrier turbidity systems as part of the Eversource Energy Seacoast Reliability Project (SRP). The project consisted of a 12.9-mile, 115 kV transmission project to improve the electrical reliability in the Seacoast region of New Hampshire. Three cables were buried approximately 1 mile across Little Bay north of Adams Point. The cables were installed using a jet plow along most of the route across Little Bay. Hand jetting was used to install cables close to shore where water depths were too shallow for the use of the jet plow.

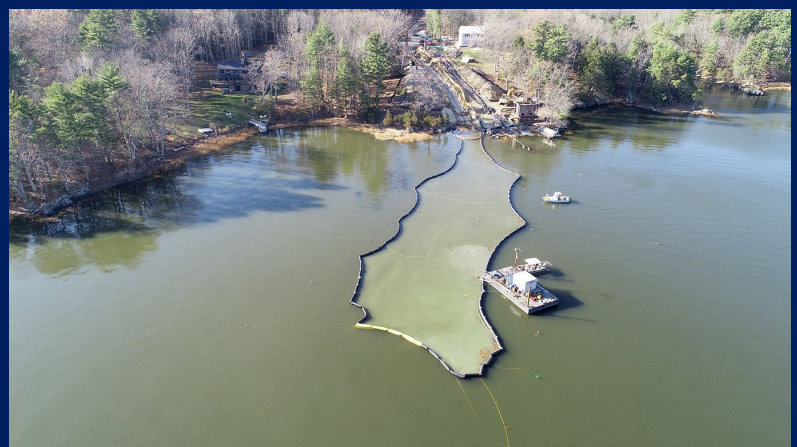
Figure 5. Drone footage of barrier during hand jetting operations

The Bottom-sealing turbidity barriers were deployed on the eastern and western tidal flats during the hand-jetting process. Each barrier consisted of a surface float, a microfabric skirt that filtered out particulates, an impervious weighted bottom foot, and a series of anchors and lines for securing the float, skirt, and foot. The barriers were utilized to contain and minimize turbidity associated with the resuspension of suspended sediments from hand jetting.
