**Project Background**

Mackworth-Enviro designed and installed a temporary re-suspension barrier system (TRB) as part of a federal harbor dry dock remediation project in Victoria, BC. The project required installing several filter barrier curtains with barge gate access to surround the jetty perimeter and dredging areas to contain re-suspended contaminated sediments (Figure 1). Contaminants of concern included metals, PCBs, TBT, and PAHs.

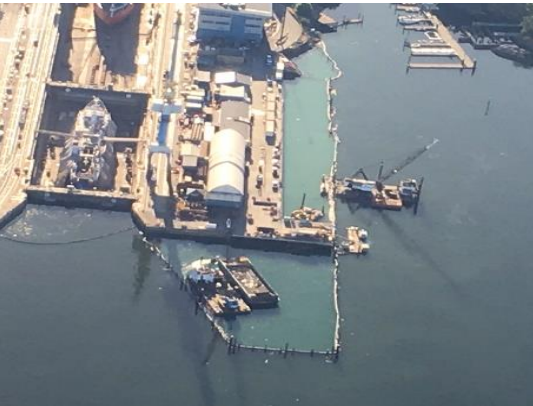
Figure 1. Aerial view of the TRB system

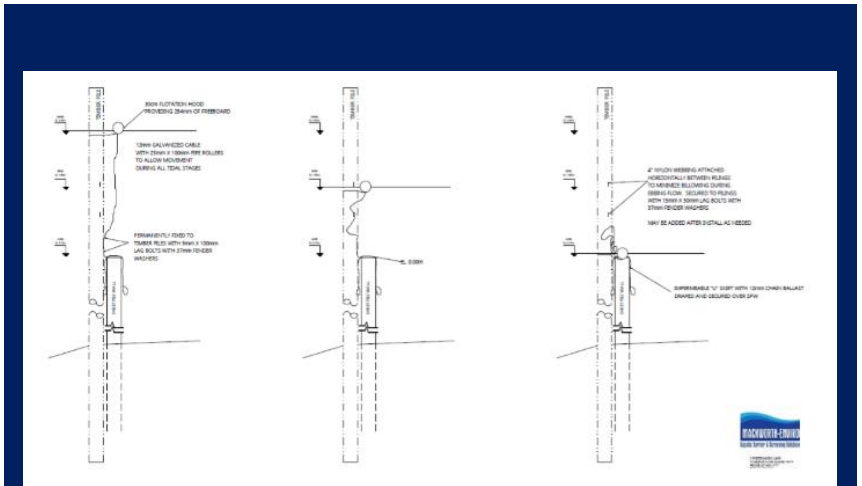
Figure 2. TRB system profile through tidal range

The system was engineered to seal to the re-driven perimeter sheet pile wall, which served as the lower portion of the TRB system to mitigate recontamination from construction activities (Berlin et al., 2017a). The TRB system also had to withstand the wide tidal range in Esquimalt Harbor and allow for water exchange (Figure 2).

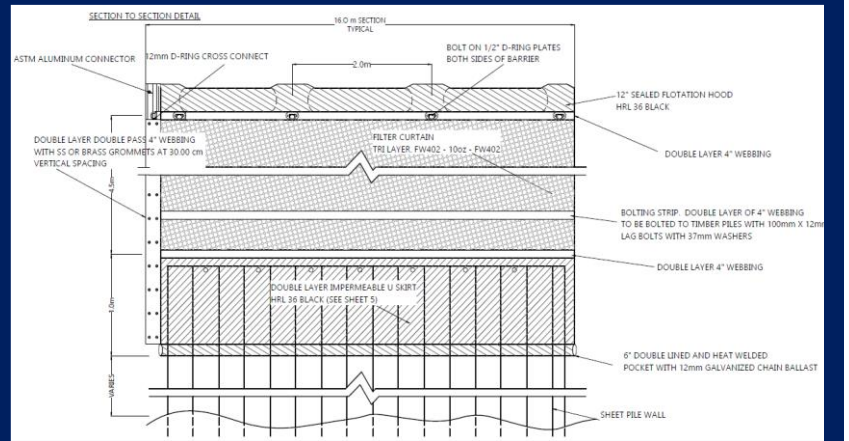
Figure 3. Design of TRB system

The silt curtains for this project were constructed of flexible, reinforced, thermoplastic material and suspended from a 30.5-centimeter flotation hood (Figure 3). The bottom of the curtain was constructed with an impermeable layer U-skirt, which overlapped on both sides of the top of the sheet pile wall that was anchored with a 14-millimetre chain ballast (Berlin et al., 2017a).
